The Navy & Marine Corps Aviation Maintenance Safety Magazine

Spring 2010
www.safetycenter.navy.mil

**The Navy & Marine Corps
Aviation Maintenance Safety Magazine**
SPRING 2010, Volume 49 No. 2

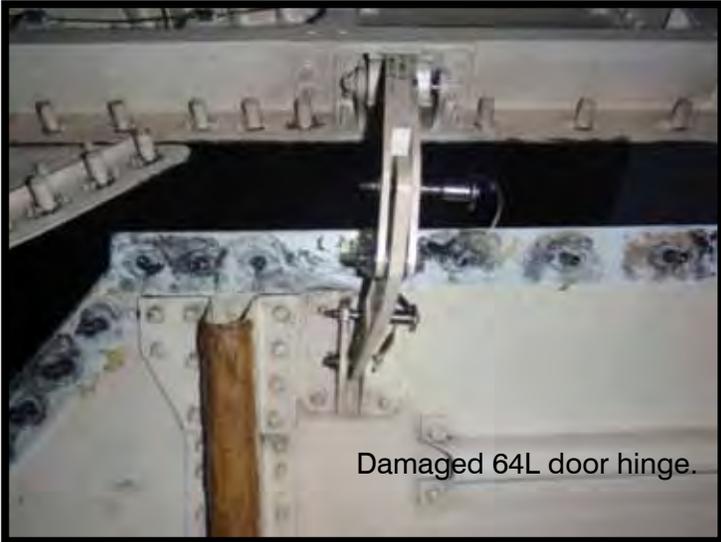
While the No. 2 engine was coming back online, I felt the flight controls move as the flaps starting going to the AUTO position. As they did, the port trailing-edge-flap (TEF) collided with the open 64-door. The PC signaled me to hold, and I raised both hands, letting him know I was "hands-off." He then went to check on what had happened and reported back to me with the bad news: We had damaged the TEF and the 64-door hinges. The PC signaled me to shut off the engines; then, we notified Maintenance Control and QA.

Damaged 64L door hinge.

Around 0330, I called on the radio to check on 403’s condition. The crew called back and told me that the door hinges were bent and the trailing-edge-flap was damaged severely. From that point on it was all statements and questions.

As the night-check Maintenance Control supervisor, I failed. I did not insist that all personnel involved in the turn evolution brief inside Maintenance Control under greater supervision. We all were tired. I just wanted to get the job done, produce an “up” jet for the flight schedule and go home. I should have listened to my MMCPO’s advice regarding senior personnel running the flight line. I took his comment as a suggestion, not a direction. Not to hang my line-shift supervisor out to dry, but perhaps a more seasoned petty officer would have caught the TEF discrepancy before it turned ugly. We now require a PO1 or above to run the radio on nights, with a QAR present as a safety observer. ✈

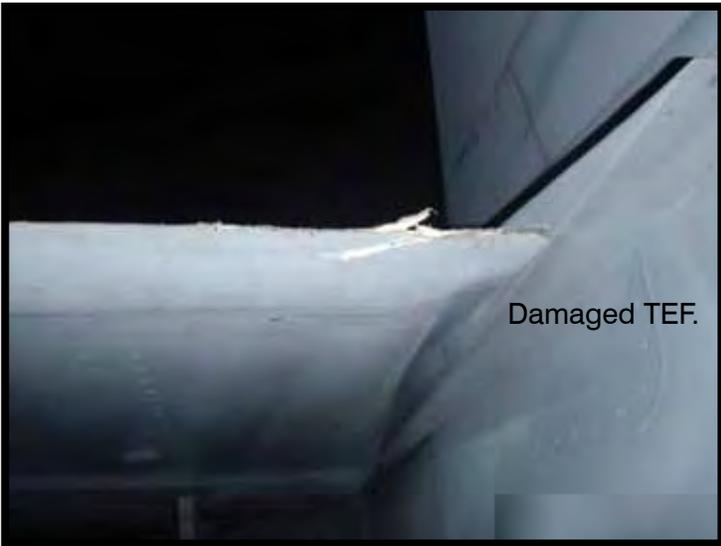
Damaged TEF.

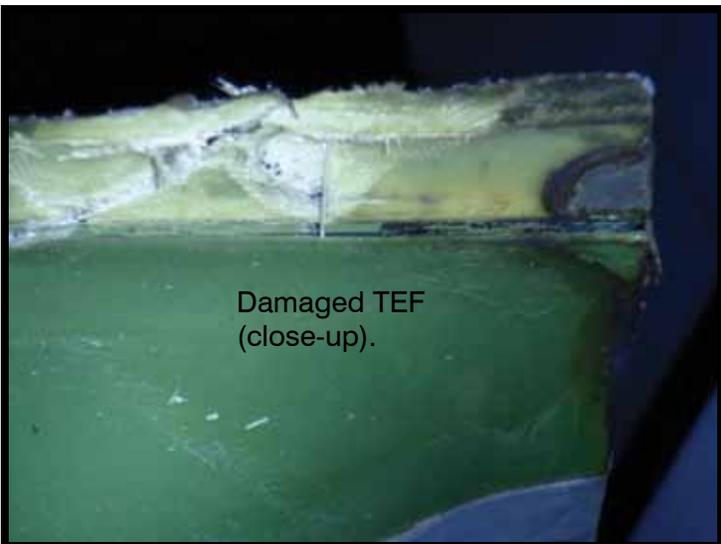
Damaged TEF
(close-up).

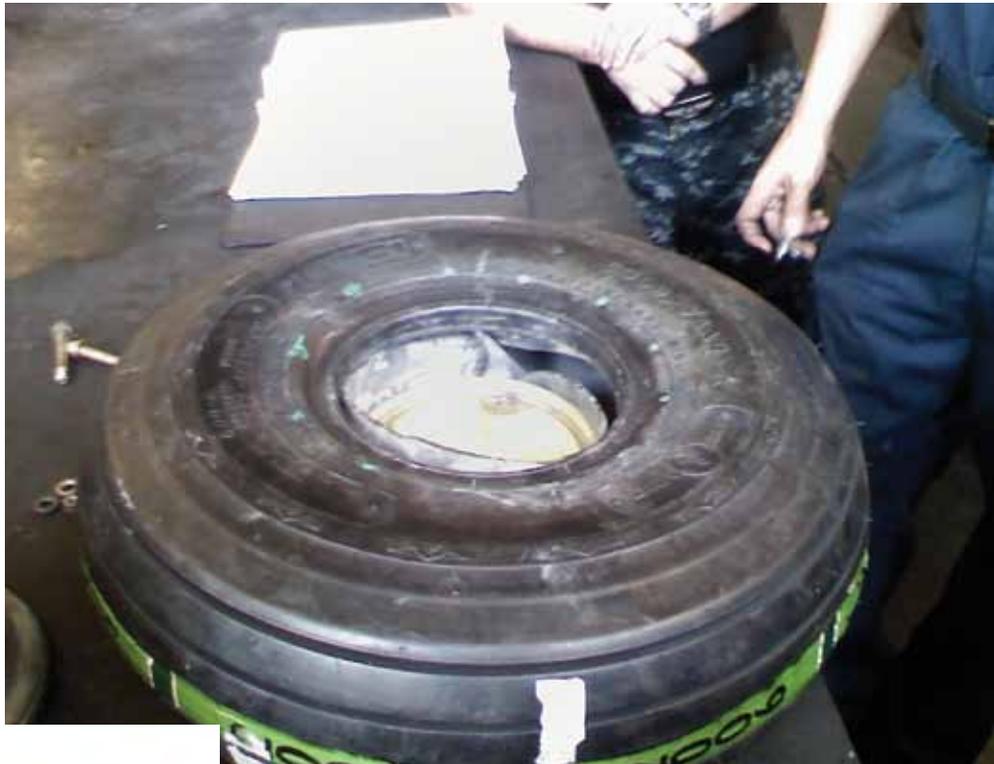
Figure 1.

on the H-60 tire, I should have adjusted the air pressure for the H-60. However, I missed this step (see figure 1.) and began to inflate the tire with the same tire pressure as the P-3 tire. After several minutes, the airman assisting me noticed that the tire-pressure gauge wasn't showing an increase in air pressure. After conducting several inspections to determine the cause, I concluded that the valve-stem-core was bad; thus, the tire should be broken down and the tube replaced.

Ref. NAVAIR 04-10-506, Section IV, Para. 4-14. f ... Using Table 4-1, locate the applicable aircraft and tire size. Inflate tire to the test pressure listed.
