The Navy & Marine Corps Aviation Maintenance Safety Magazine

Spring 2010
www.safetycenter.navy.mil

**The Navy & Marine Corps
Aviation Maintenance Safety Magazine**
SPRING 2010, Volume 49 No. 2

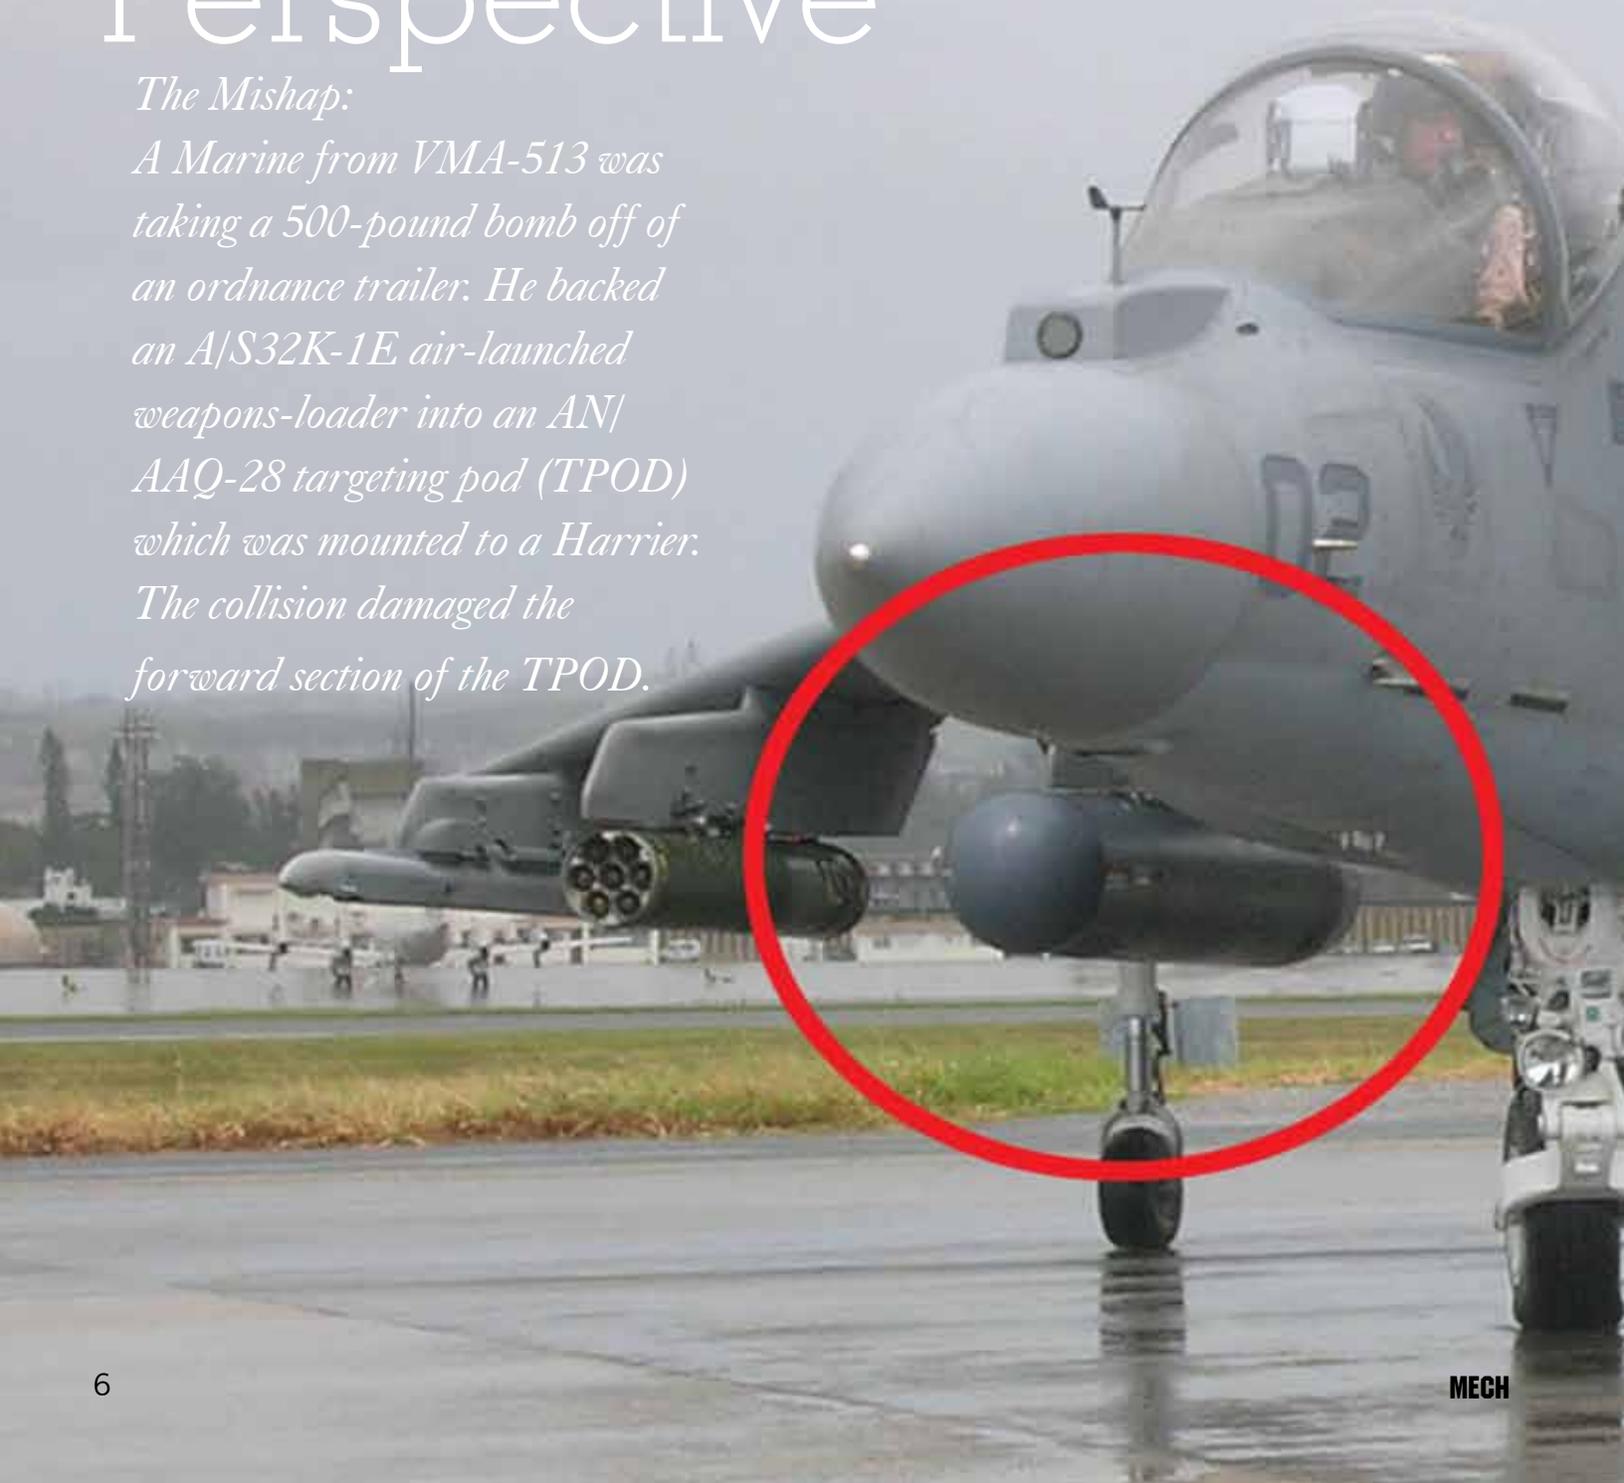
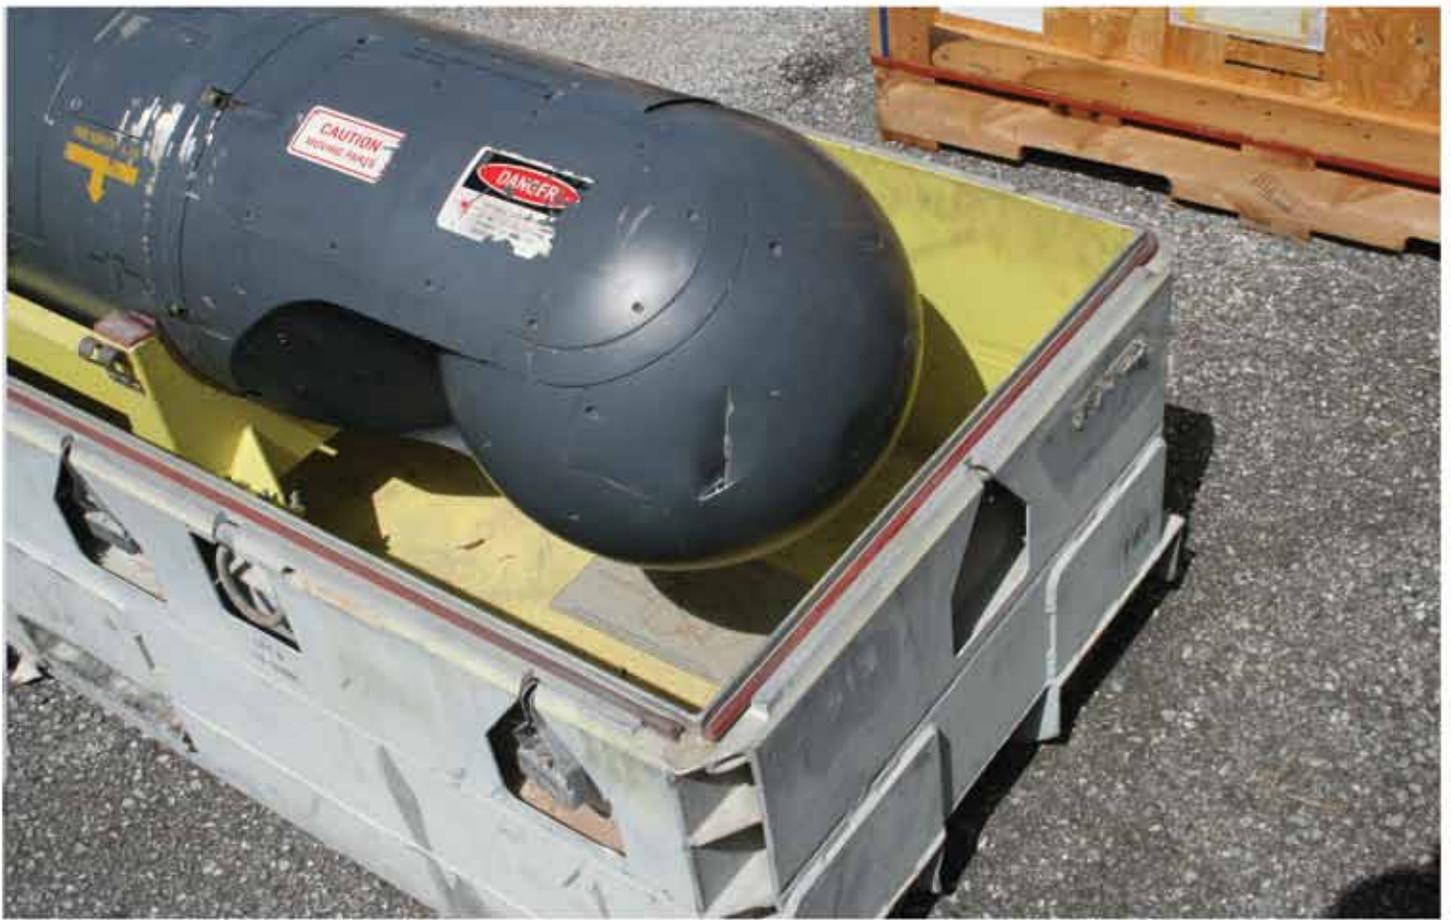
A Marine from VMA-513 was taking a 500-pound bomb off of an ordnance trailer. He backed an A/S32K-1E air-launched weapons-loader into an AN/AAQ-28 targeting pod (TPOD) which was mounted to a Harrier. The collision damaged the forward section of the TPOD.

He had been looking over his right shoulder, focused on clearing an LAU-7 launcher also mounted to the aircraft. A taxi director had yelled for him to stop, but, because of airfield noise, he didn't hear the director's commands. The result: The aft left-portion of the loader ran into the forward section of the TPOD. The damage, though superficial, easily could have been in the Class-C range if the loader had hit harder.

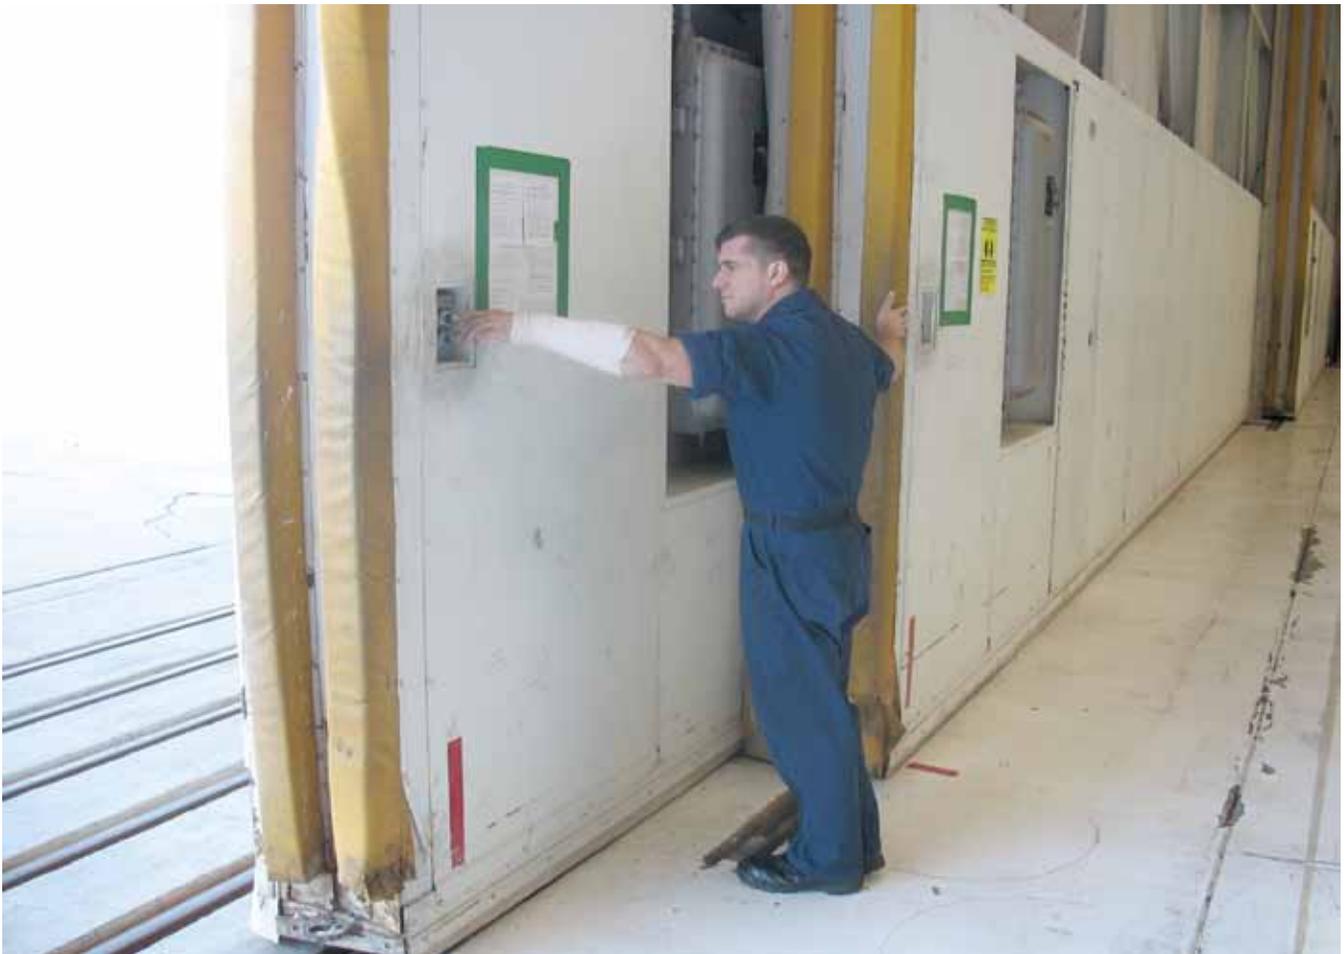
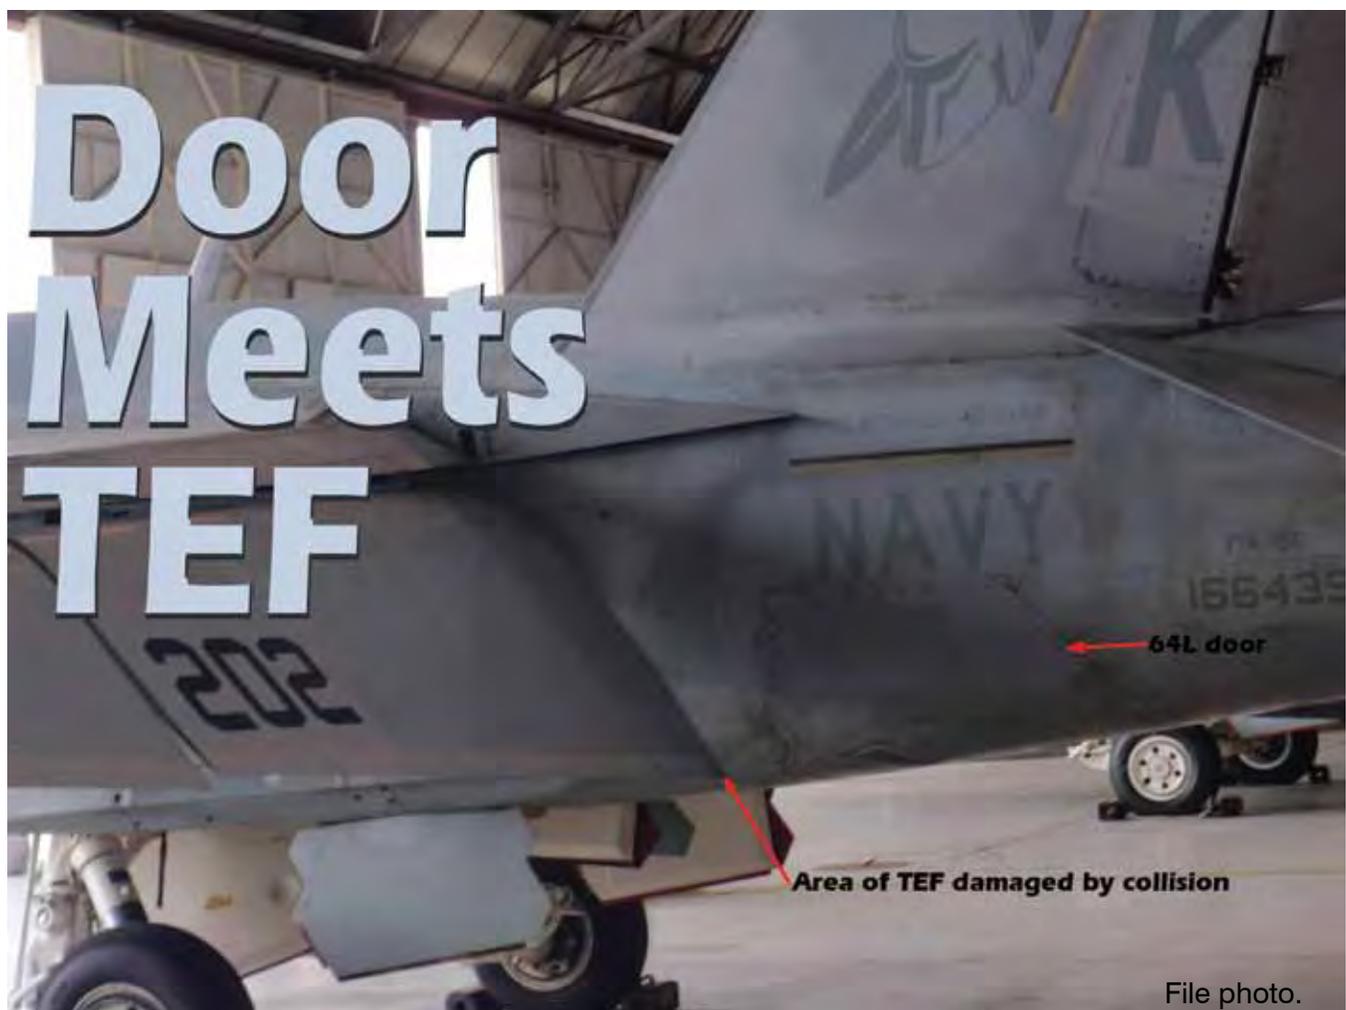
While the No. 2 engine was coming back online, I felt the flight controls move as the flaps starting going to the AUTO position. As they did, the port trailing-edge-flap (TEF) collided with the open 64-door. The PC signaled me to hold, and I raised both hands, letting him know I was "hands-off." He then went to check on what had happened and reported back to me with the bad news: We had damaged the TEF and the 64-door hinges. The PC signaled me to shut off the engines; then, we notified Maintenance Control and QA.

Damaged 64L door hinge.

Damaged TEF.

Damaged TEF
(close-up).

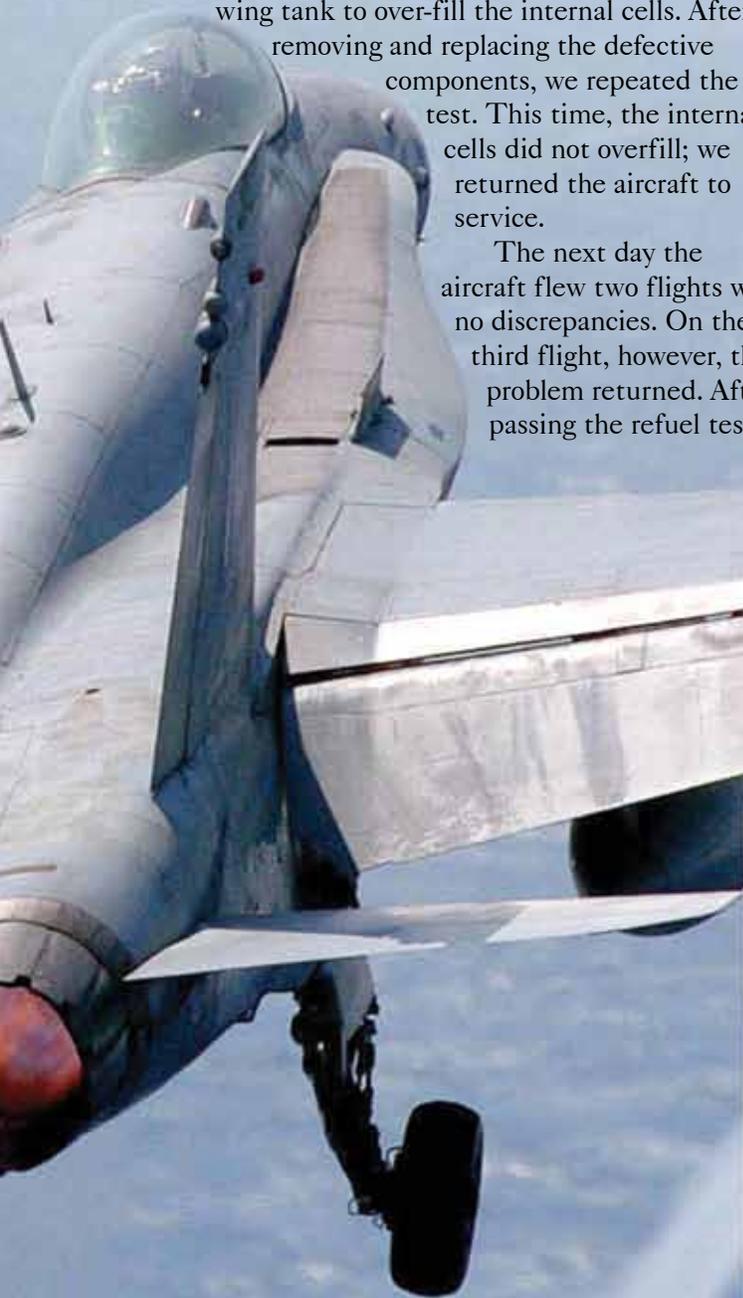
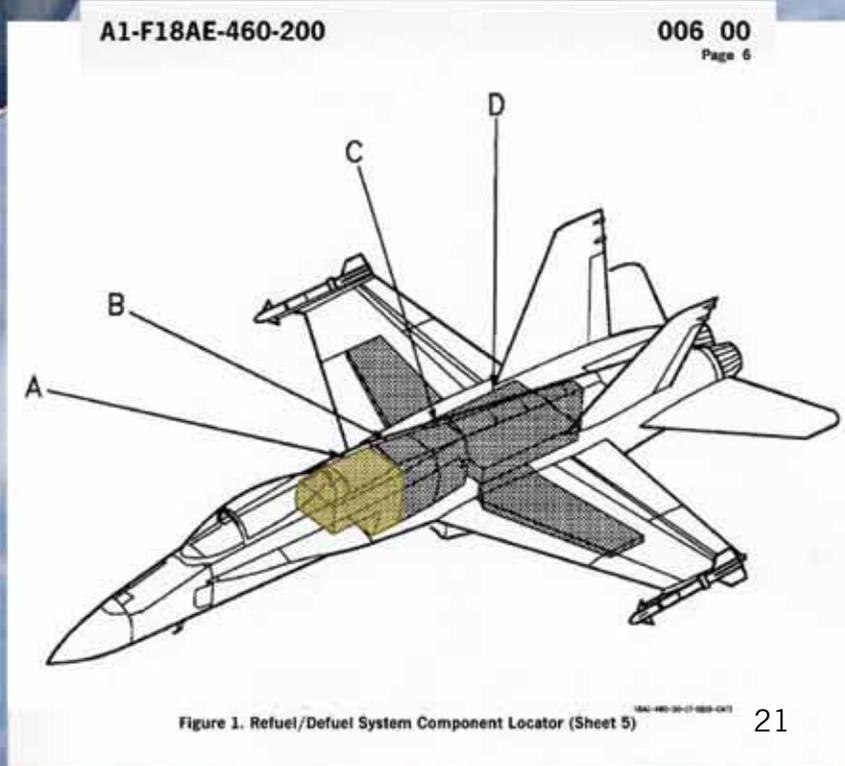
First, we dropped the port-side motor to access the vent tank. An inspection of the area revealed that the y-line from the fuel dump was cracked and likely a contributing factor to our ongoing discrepancy. After replacing the automatic drain-valve in the vent tank—and repairing the y-line—we prepared to refuel the aircraft and check our work.

went. The automatic drain-valve in cell-4 had failed and was the apparent cause of our pre-check problem. After replacing it, we op-checked and leak checked 312, using both the refuel and transfer pressurization-tests. After successful completion of all, maintenance again returned aircraft 312 to service.
