The Navy & Marine Corps Aviation Maintenance Safety Magazine

Fall 2010

**The Navy & Marine Corps
Aviation Maintenance Safety Magazine**
Fall 2010, Volume 49 No. 4

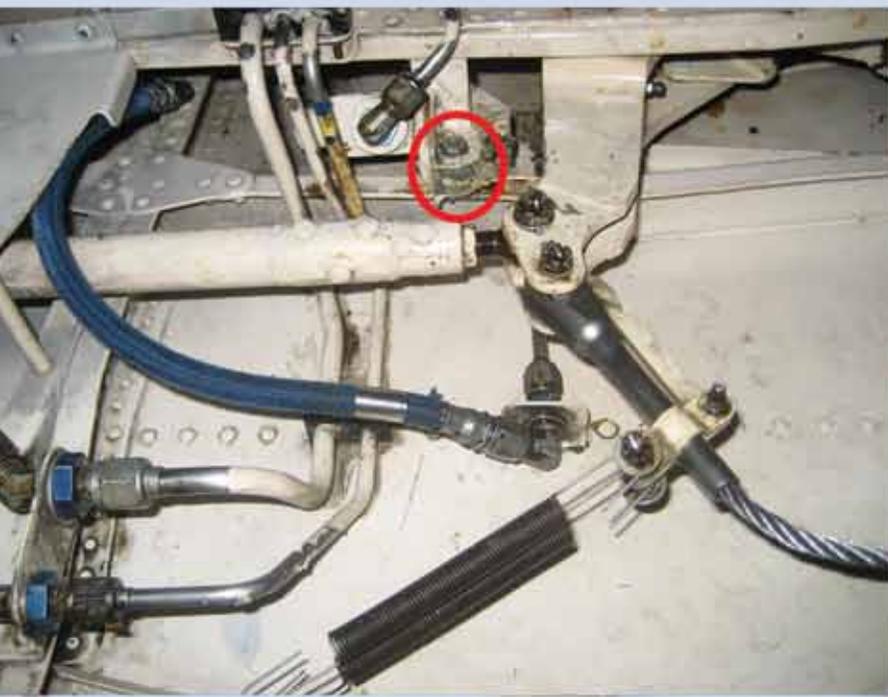
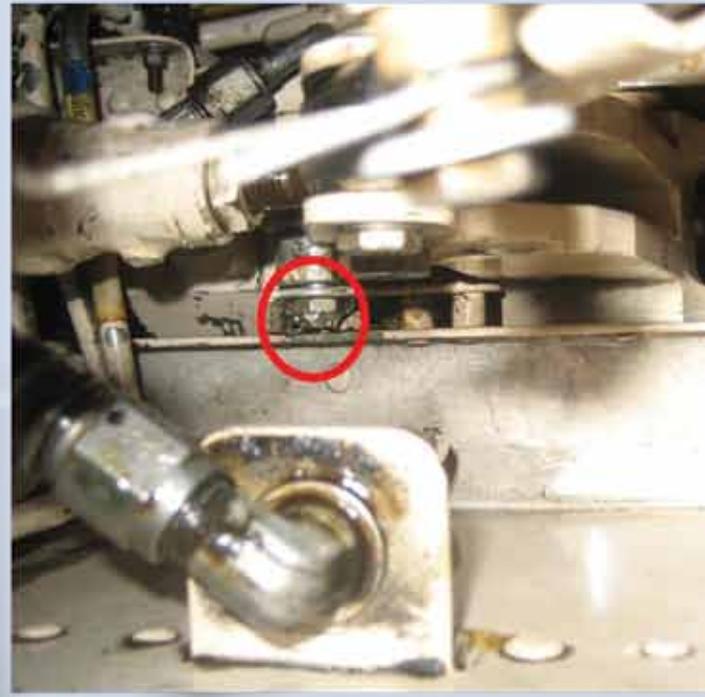
The E-2C landing gear system is designed with a hydraulic timer check-valve mounted on the forward bulkhead of each main-landing-gear wheel well. The valve routes hydraulic fluid to the main-landing-gear

actuators when the forward-landing-gear doors are open fully. The timer check-valve is actuated by a striker bolt which is depressed by a cam assembly on the forward door linkage when the doors are open fully.

Following the senior chief’s direction, the supervisor did another visual inspection of the right main-landing-gear hydraulic components and noticed the striker bolt on the timer check-valve was slightly worn, causing it to be out of adjustment.

On Black Eagle 602, the worn striker bolt was not fully actuating the valve. This, the supervisor realized, was probably the reason why the landing gear did not extend when the pilot placed the landing gear handle in the down position during the previous flight.

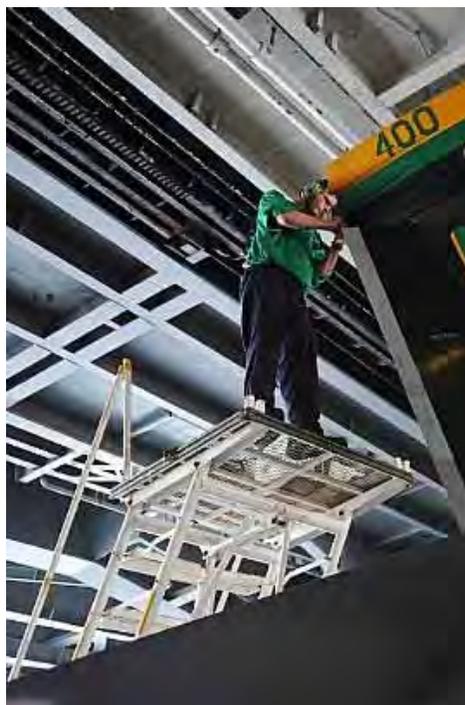
- Overloading the stand.
- Personnel hanging over the sides while working from them.
- Platform raised and not locked, including when not in use.
- Personnel working with hands, arms or feet extended through the scissors lift assembly (and unaware of the hazard if the platform were to come down).
- Safety rails missing (as shown in photo on the right).
- Equipment checked out with no pre-operational inspection.
- Stands in use with the lock pins missing, hydraulic hoses damaged, and/or structural corrosion.
- No PPE worn while using platform.

Solutions: Personnel need to know how to inspect, use, and care for maintenance platforms. Special emphasis should be taken to train Sailors and Marines on SE, including equipment

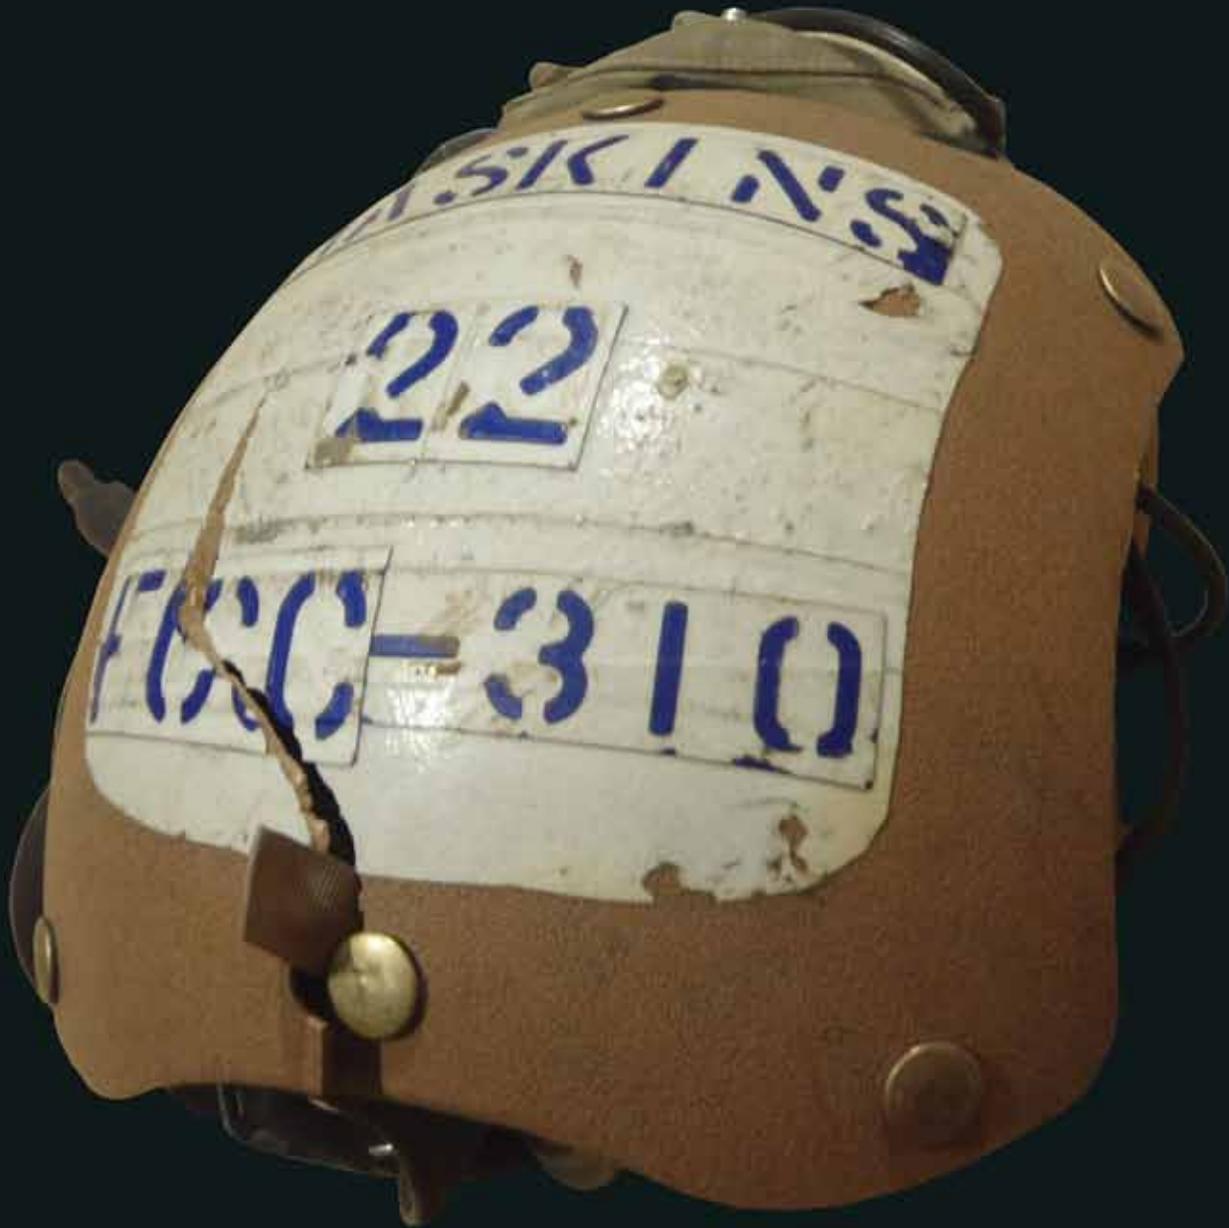
This thin plastic shell absorbed the impact of a Marine's head-first fall from 15 feet and spared him from serious injury or death.
