The Navy & Marine Corps Aviation Maintenance Safety Magazine

# Mech

Summer 2010

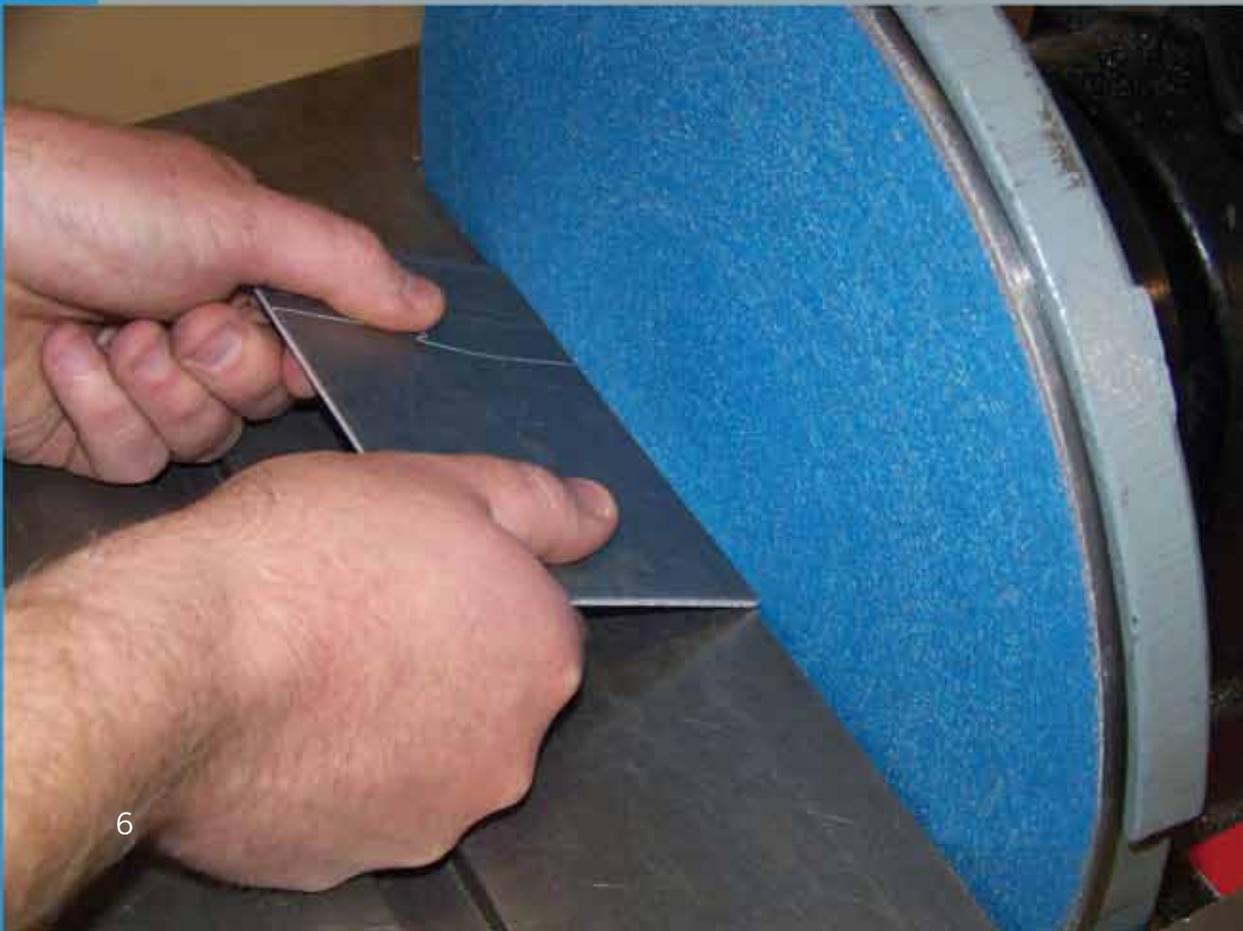
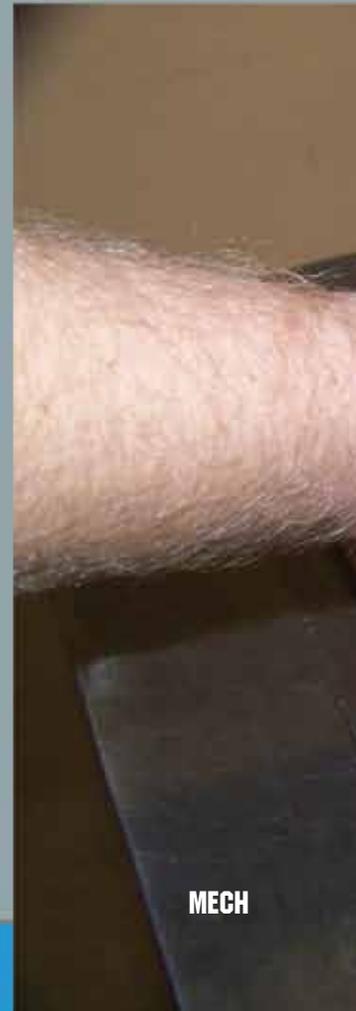
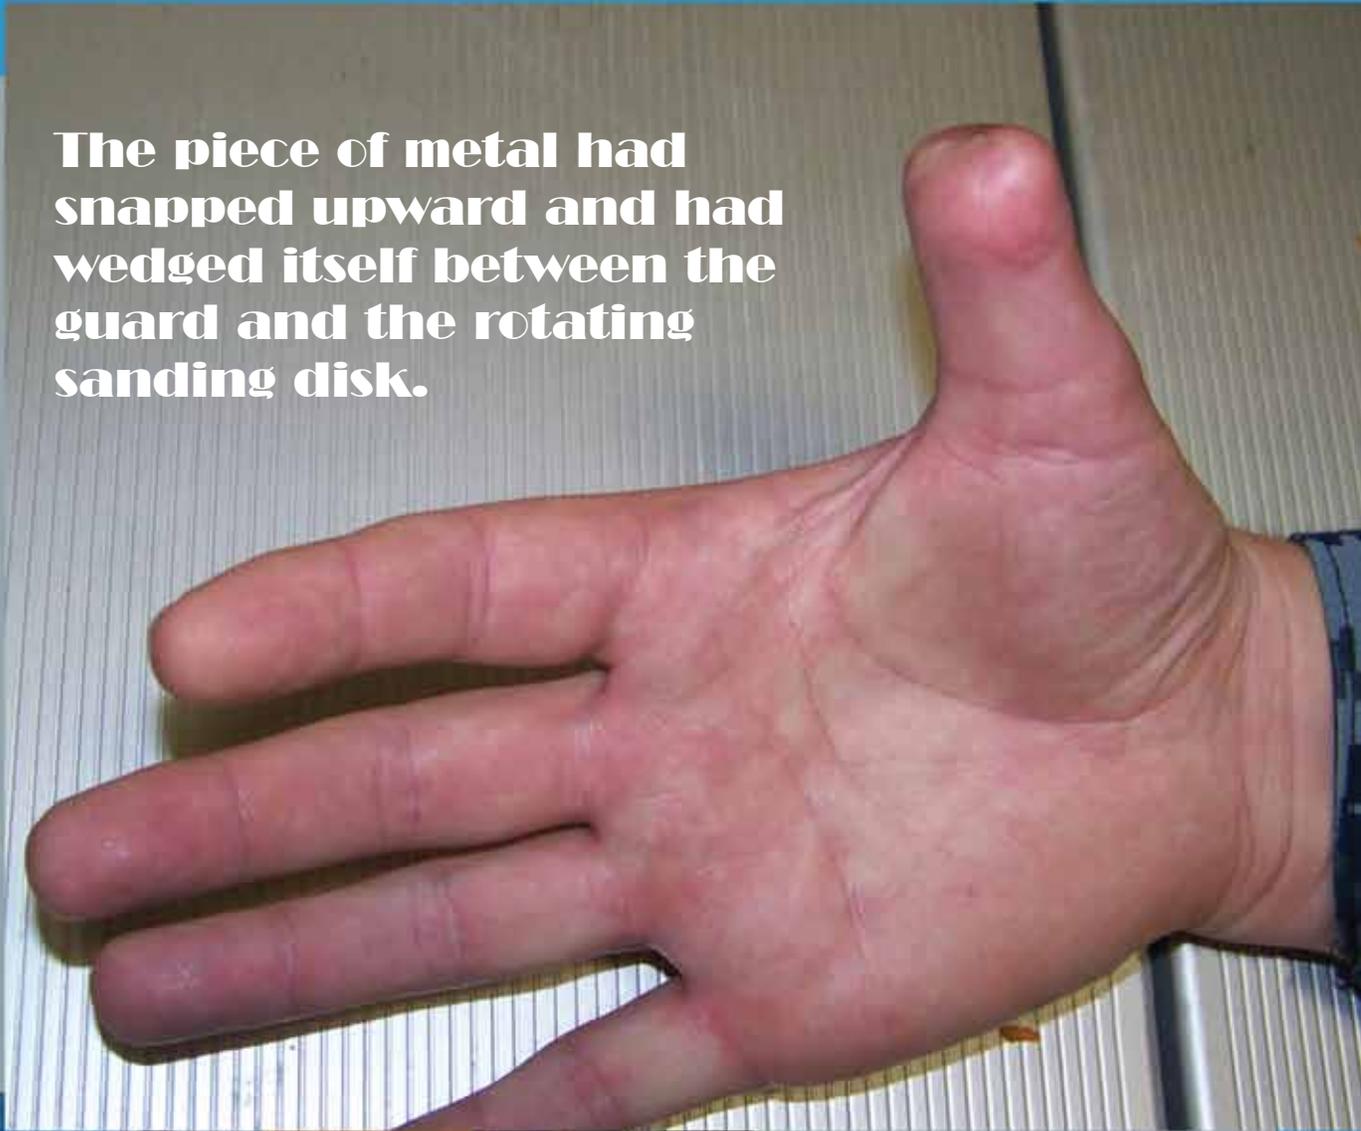
**The piece of metal had snapped upward and had wedged itself between the guard and the rotating sanding disk.**

replaced with a new 50-grit disk. Also, I would have found that the guard had been adjusted to nearly the same thickness as the metal I was grinding. According to the operations manual, the guard should have been set an eighth of an inch from the sanding disk.
